CONSTRUCTION OF CRACK-FREE BRIDGE DECKS: FINAL REPORT

A Report on Research Sponsored by
Construction of Crack-Free Bridge Decks
Transportation Pooled-Fund Program
Project No. TPF-5(174)

Structural Engineering and Engineering Materials
SM Report No. 121
December 2016

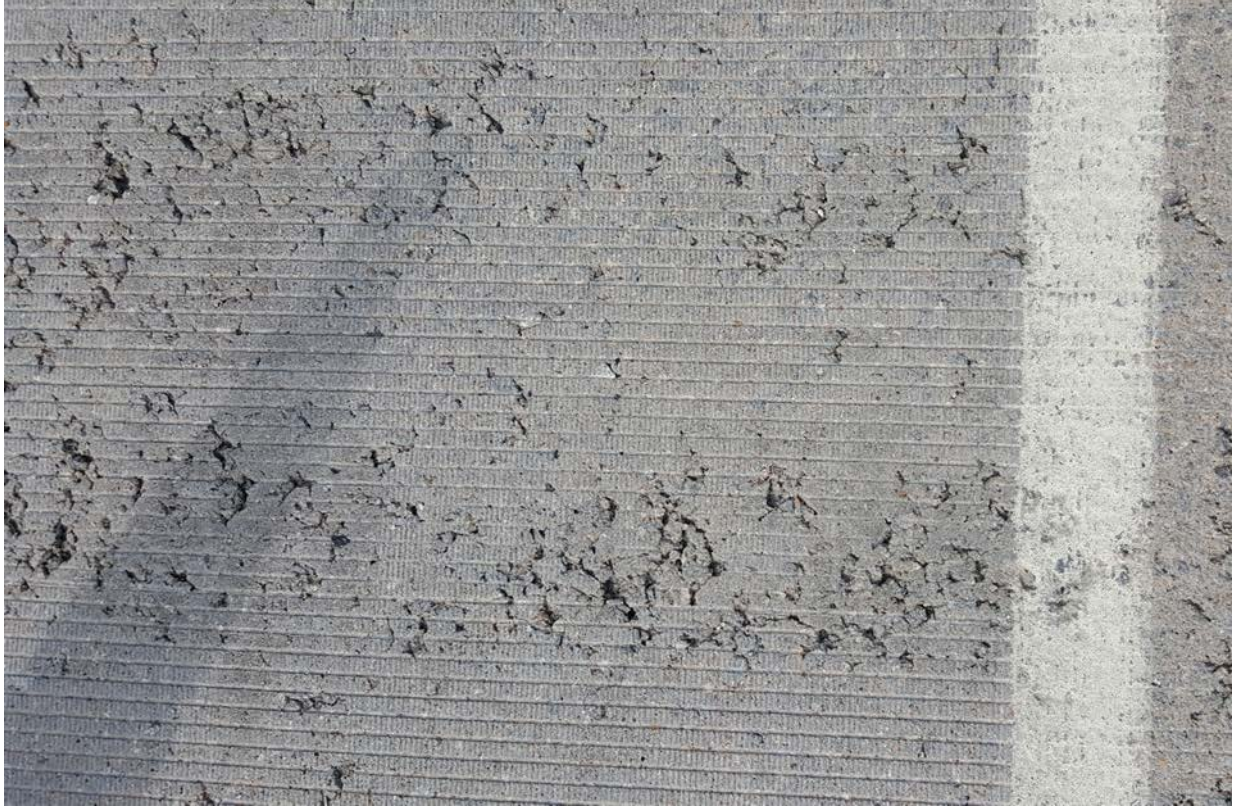
Figure 4.24: Surface Voids in LC-HPC-5 Bridge Deck

It was noted during the surveys that surface voids were present on the deck, likely due to incomplete finishing. These voids were noted in the construction report for LC-HPC-5 as being present immediately after bullfloating. Figure 4.24 shows a photo of a portion of the deck taken during Survey 8 illustrating these voids.

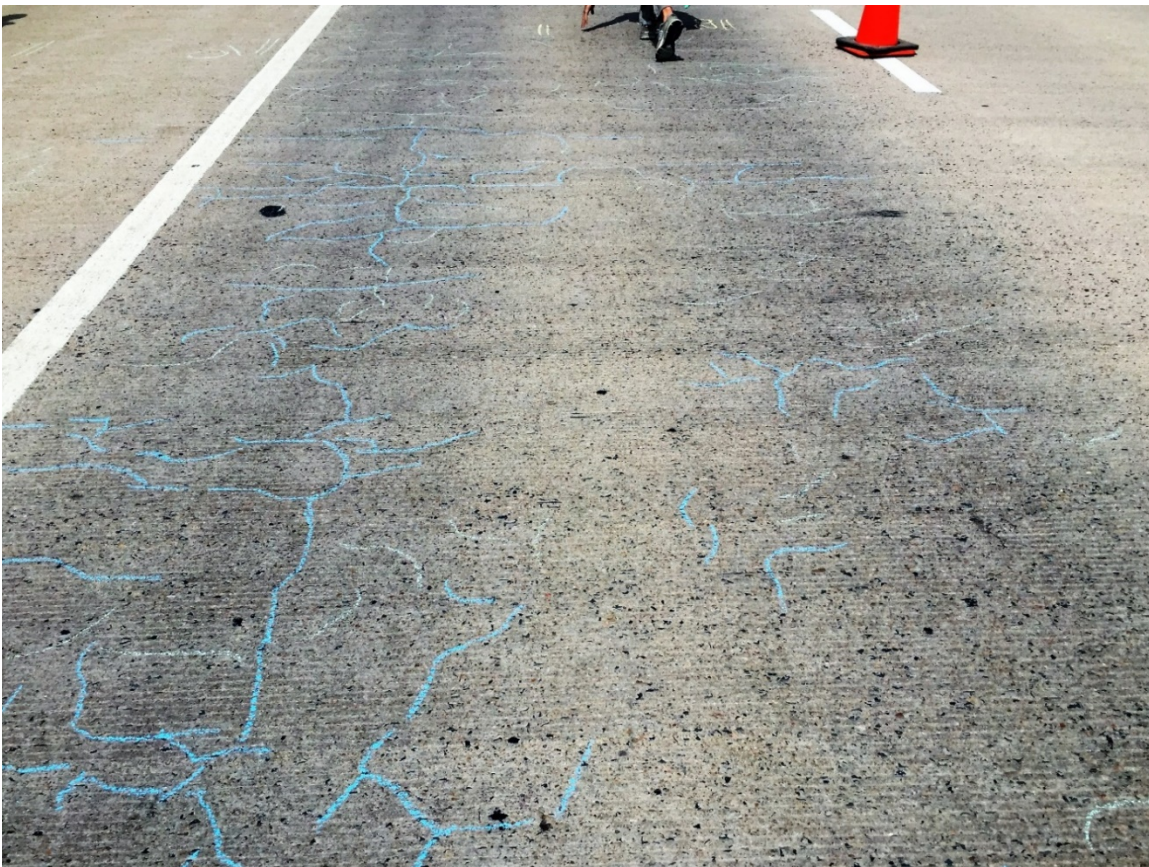
Figure 4.51: Short map cracks and discolored surface on south lane
